ENGINEERING CASE LIBRARY

A HELICOPTER'S LAST HOP

A helicopter was making a turn and slowing to get into position to deposit a load transported at the end of a sling. The helicopter crashed, killing the pilot, and demolishing the helicopter. What happened?

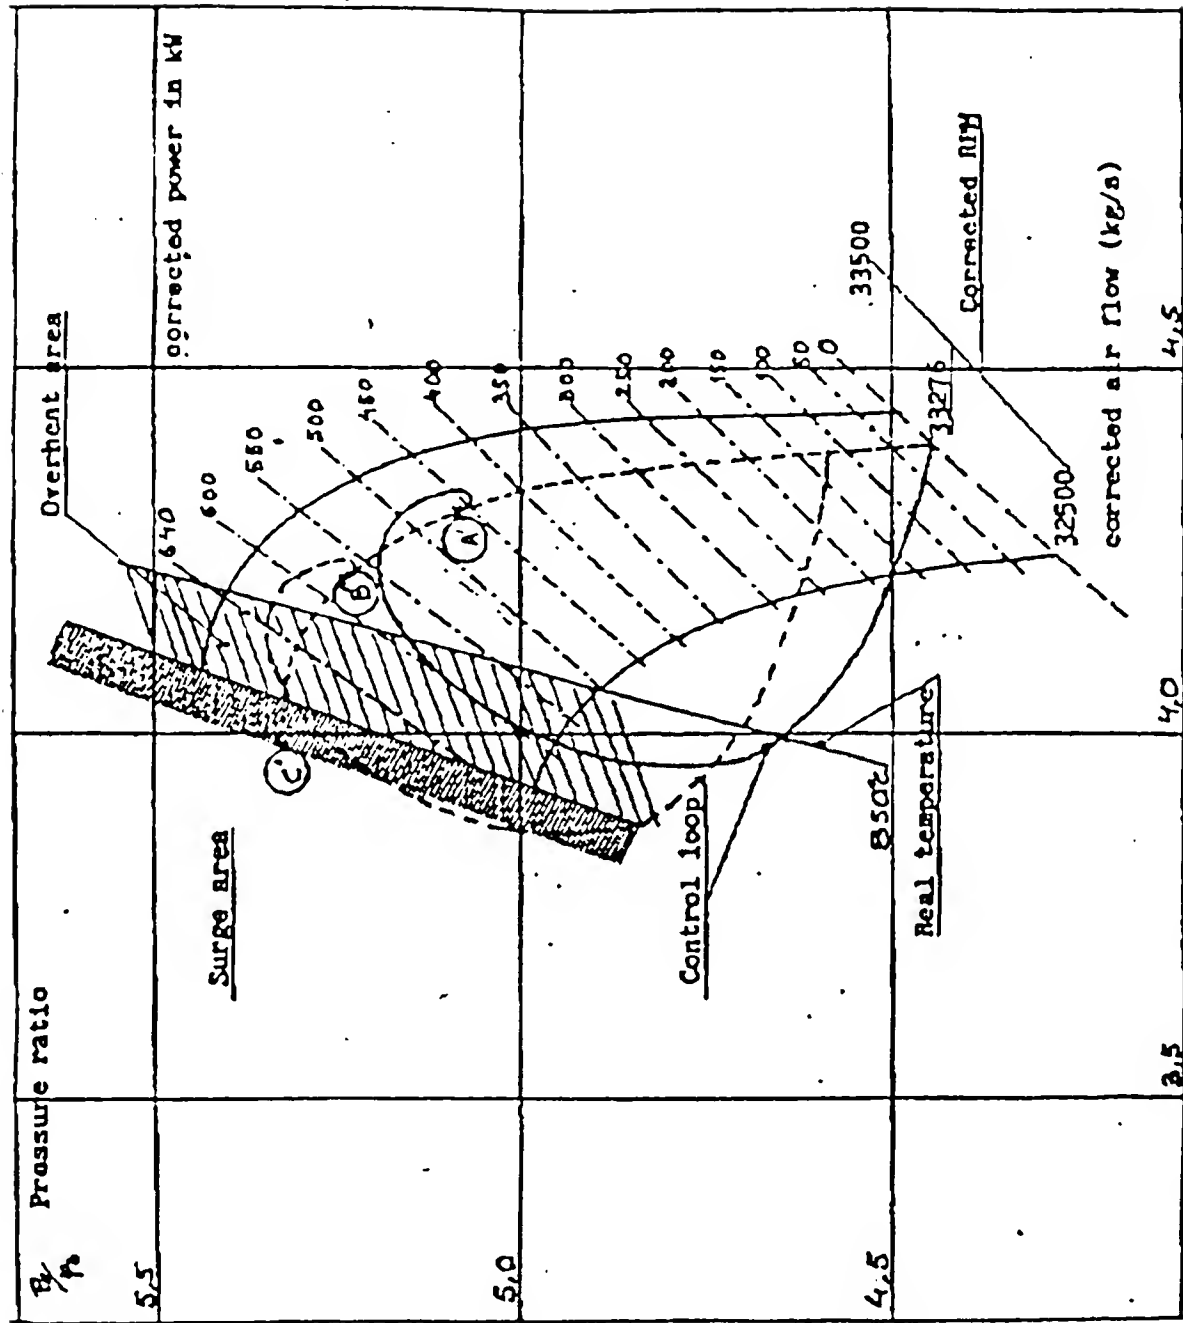
The three above values are pointed on the
diagram

Performance chart relating "corrected" power, "corrected" speed, normal control loop, overheat region, and surge (burnout) region for the failed engine.

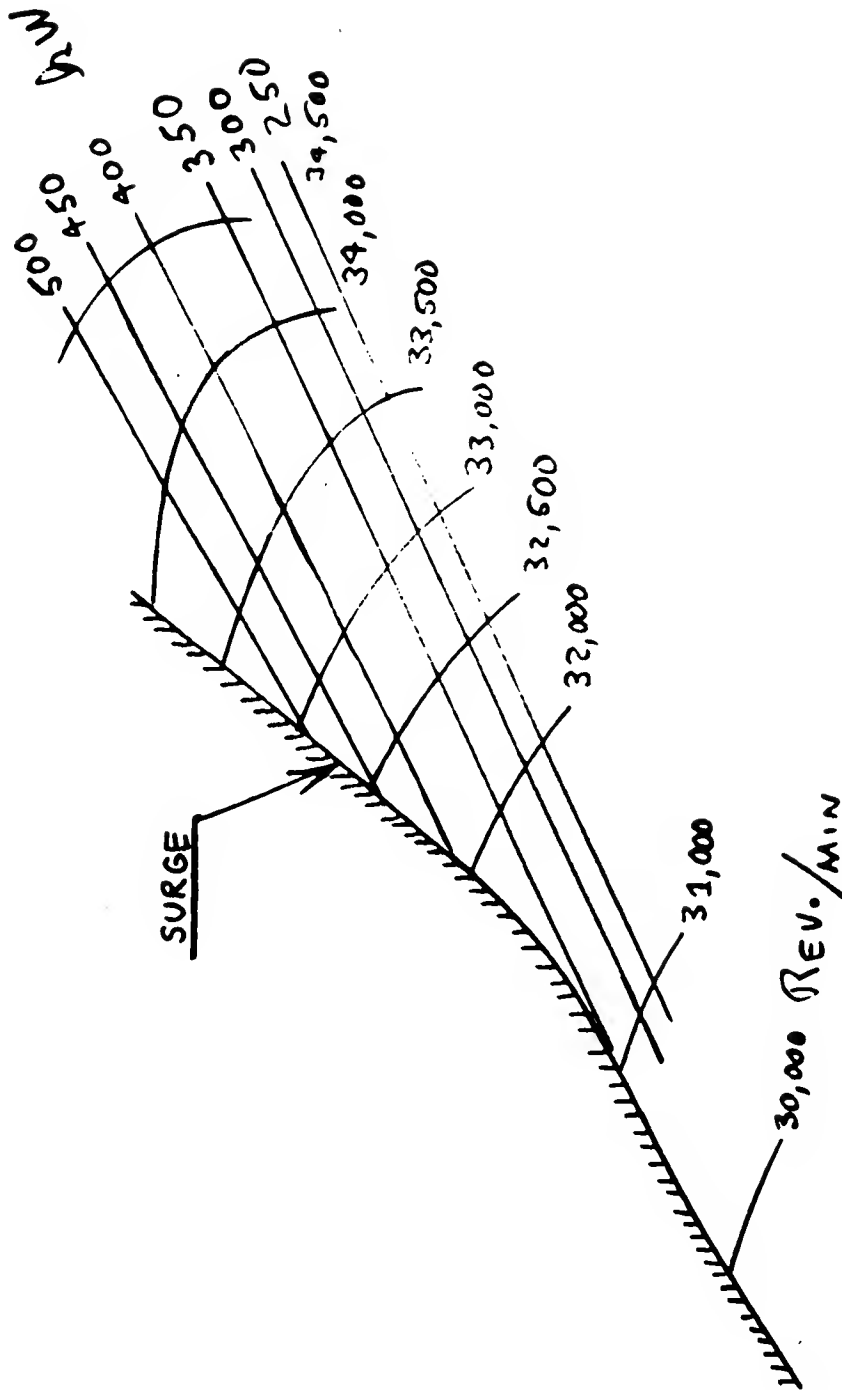
Exhibit 5

Engine thermal limit 640 kW

Exhibit 6: Sectional performance chart showing power, speed, and surge region for the failed engine at an altitude of 8500 ft (2590 m).
